# Bloekombos Dam (H800/13): Second Dam Safety Evaluation Report

**Hessequa Local Municipality**

Ref no. 1000877-0000-REP-WW-0002

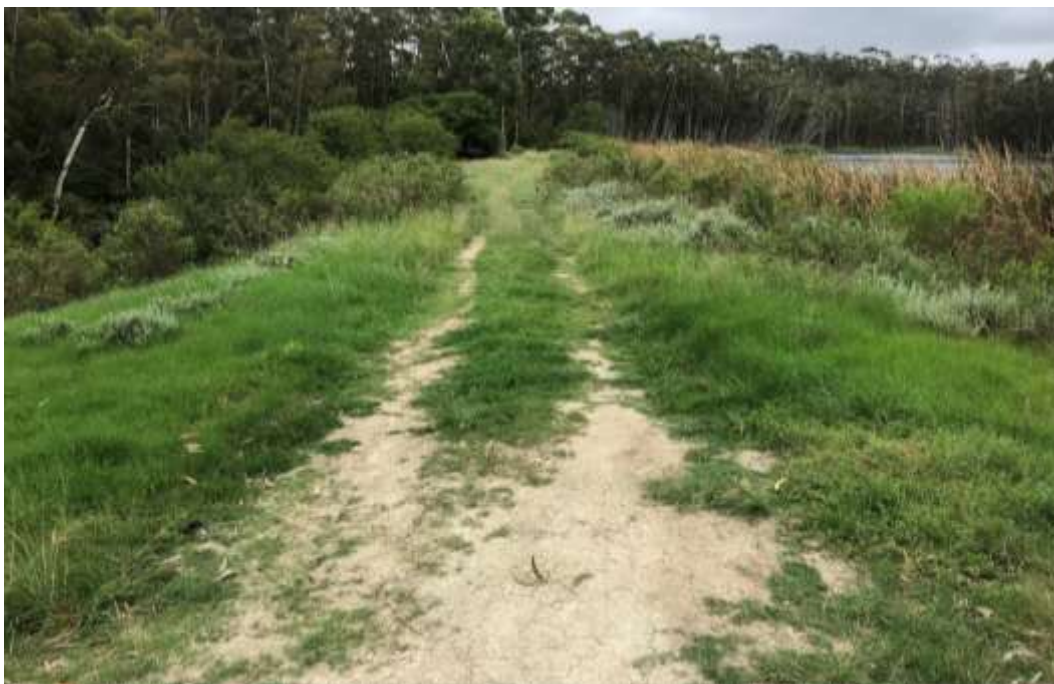
**Figure 4-2: View of embankment crest from the left abutment**

**Condition of crest:** In fair condition. Approximately 4-5 m wide crest, but narrower in places where downstream slips have occurred. The crest appears to be frequently used for access and has visible wheel rutting on it (see Figure 4-2).

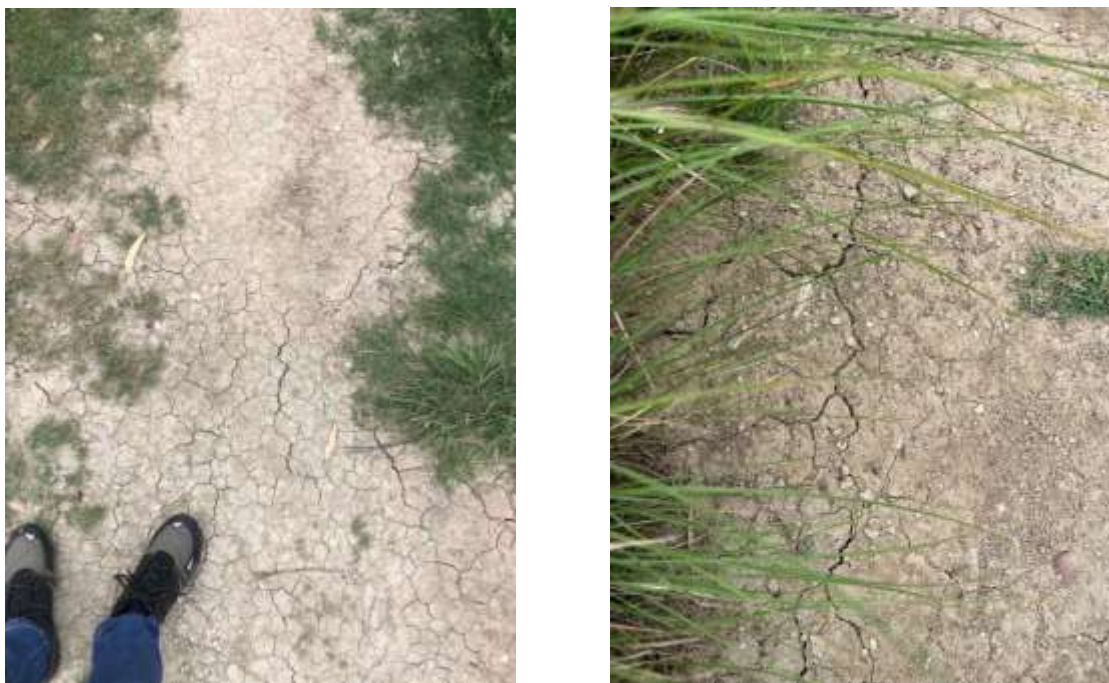
**Figure 4-3: Desiccation cracks observed along length of the crest**

**Cracking:** Evidence of desiccation cracks due to lack of a gravel capping layer were observed (see Figure 4-3).

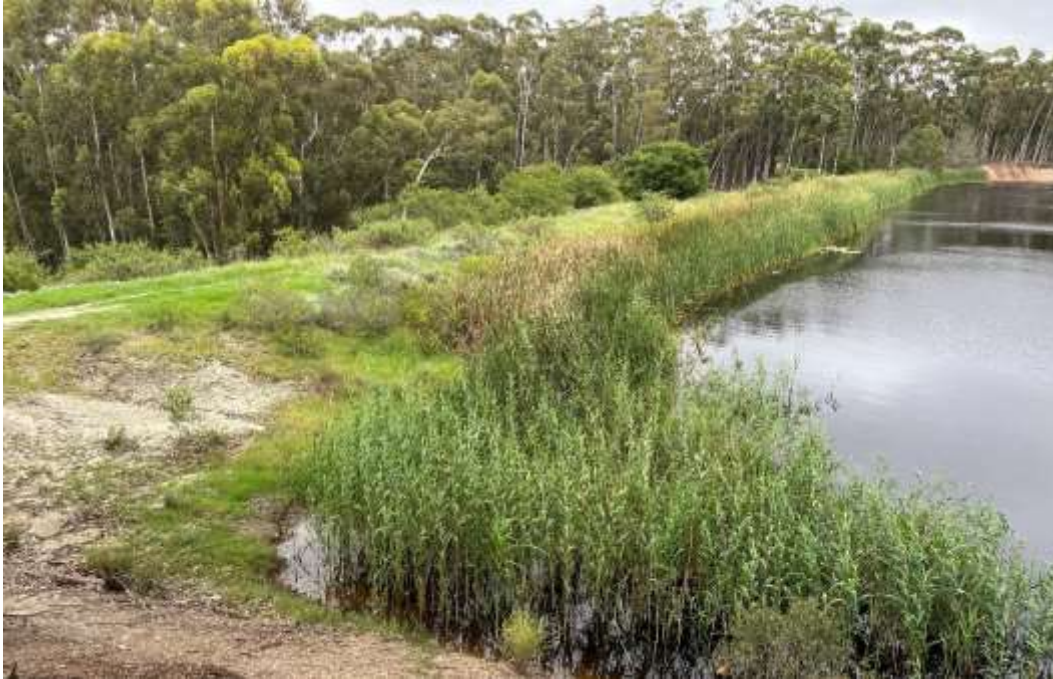
Figure 4-4: View of the upstream face from the left abutment

**Slope protection:** There is evidence of small sized gravelly rip rap protection. The face was mostly under water on the day of the inspection (see Figure 4-4).

**Condition of face:** The upstream face was mostly under water on the day of the inspection however, the exposed portion of the face appears to be in a fair condition. The water line could not be inspected due to vegetation (reeds) growing on upstream face.

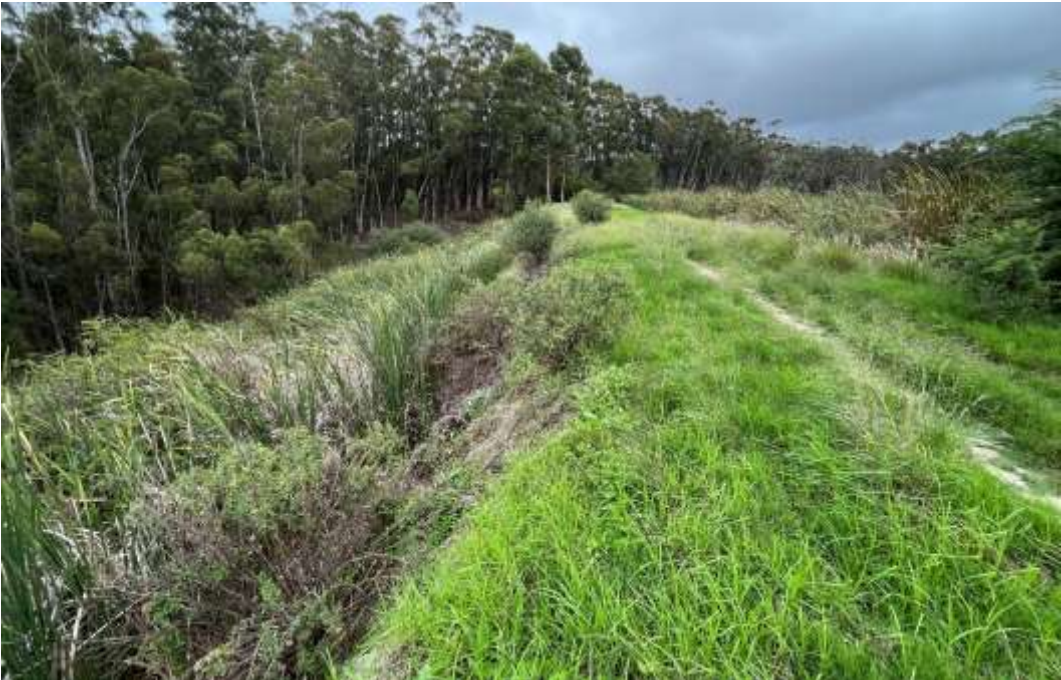
Near the middle and towards the right flank, the slopes have slipped and are **near vertical** about a third of the way down the slope (see Figure 4-5 -and Figure 4-6). Longitudinal cracks are forming near the crest where the slipping is starting. This is likely due to the seepage which is evident from the

concentration of reeds some 3 m below the crest. There is also seepage near the bottom of the downstream slope and at the toe.

Figure 4-5: Surface slip near right abutment. Note reeds growing where seepage likely daylights.

The very steep slopes, now covered in vegetation need to be rehabilitated to ensure the long-term stability of the structure.

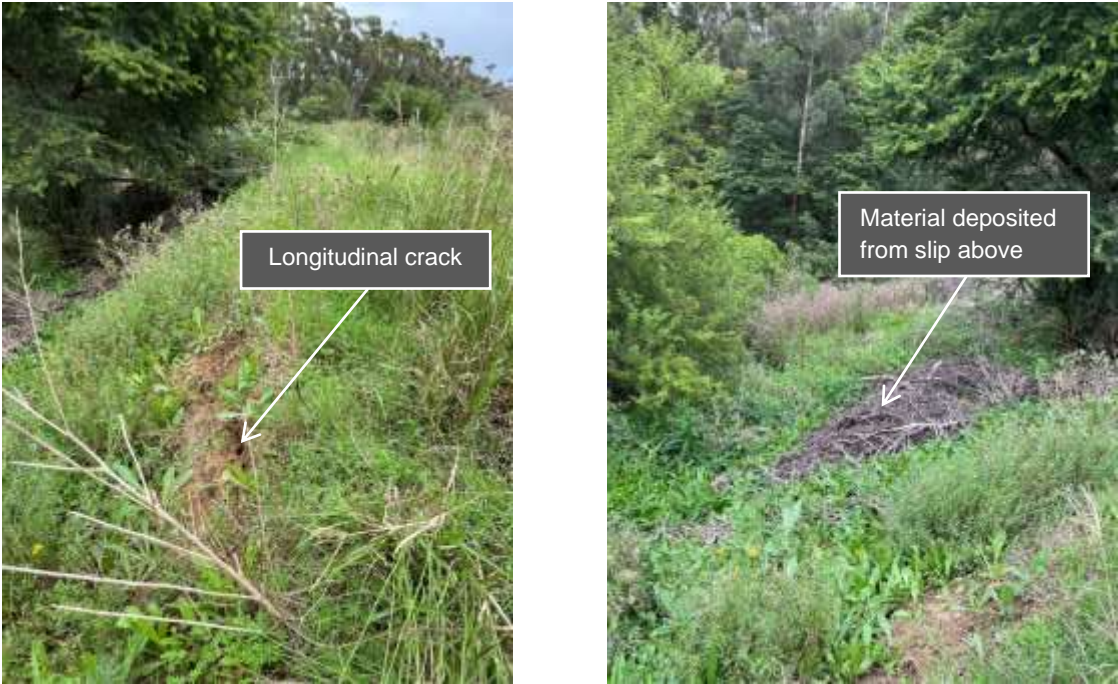
Figure 4-6: Steep sections caused by surface slips. Note thick vegetation and large trees on DS face.

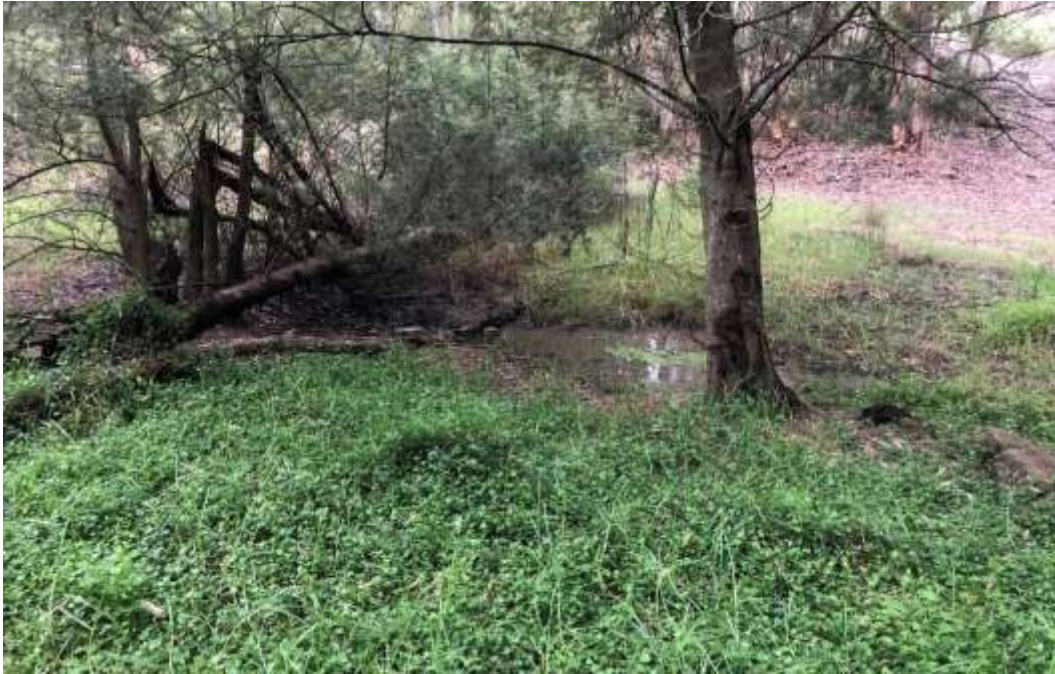
**Figure 4-7: Audible stream and ponding at downstream toe**

**Seepage, drainage and pressure relief:** An audible stream of water was noted flowing down and away from the toe of the dam as seen in Figure 4-7 above and in the vicinity of the outlet pipe. The exact source could be a combination of seepage, valve leakage and runoff and needs to be further investigated.

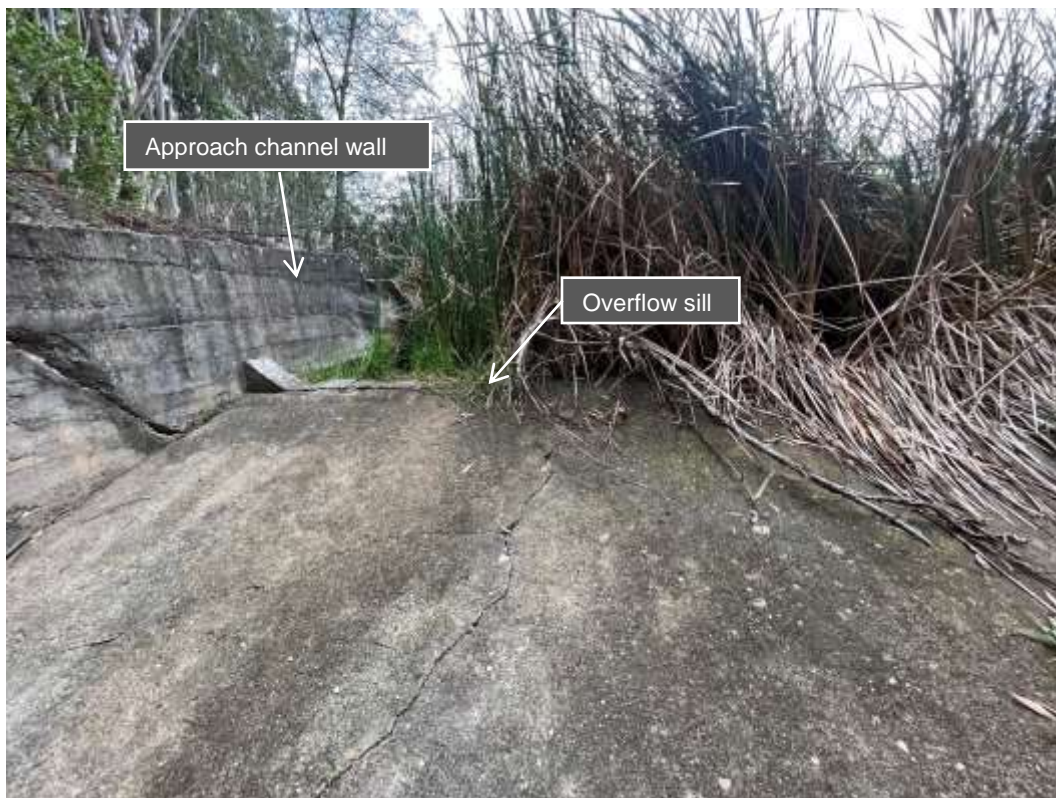
**Figure 4-8: Looking upstream towards overflow sill. Note clogged with vegetation**

**Vegetation:** Vegetation has been allowed to establish around the spillway inlet sill to such an extent that it will severely restrict the approach flow toward the spillway.

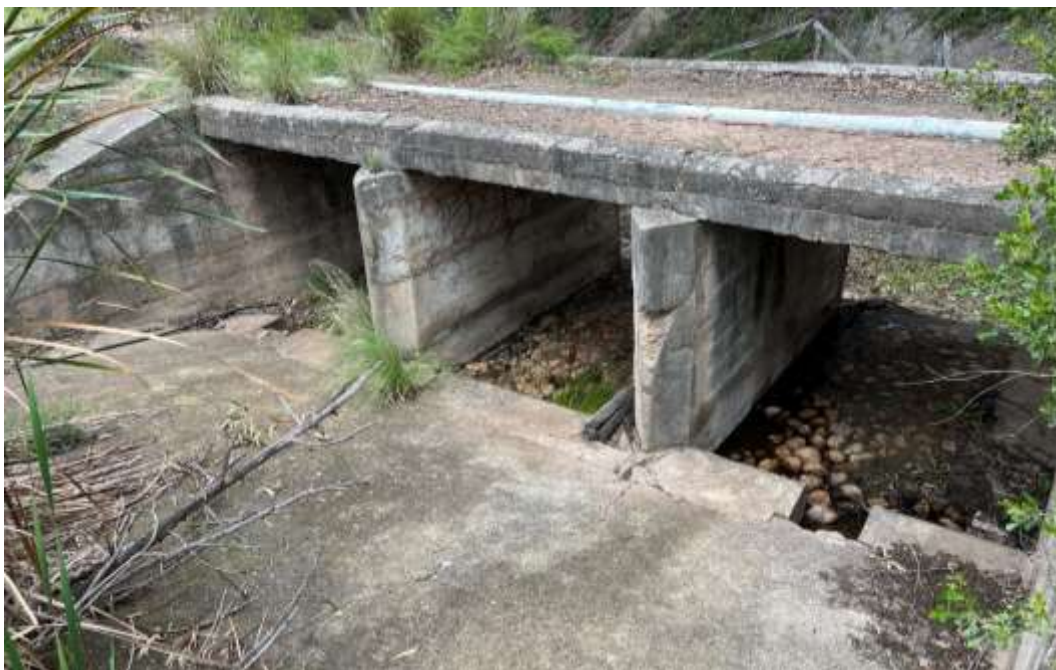
**Figure 4-9: Looking downstream along spillway discharge channel**

**Description:** Located on the right flank, it consists of an 8 m wide sill. Flow is directed down from the sill and under a bridge which spans the 8 m wide, 1.7 m discharge channel with two concrete piers (see Figure 4-9).

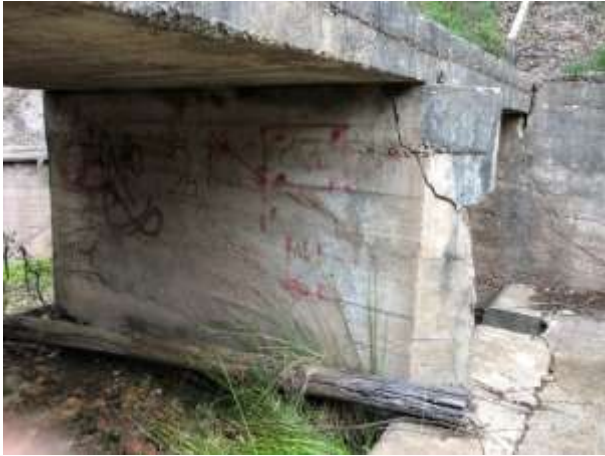
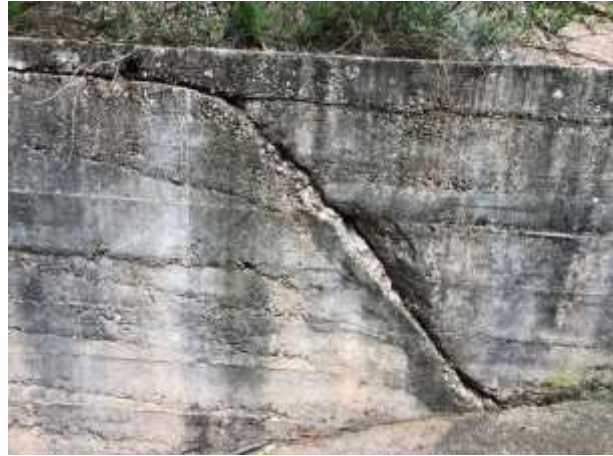
**Condition:** In fair condition, with a lot of cracking concrete

**Ageing of materials:** The concrete on the spillway structure is showing signs of ageing and will eventually require refurbishment (see Figure 4-10).

**Figure 4-10: Damaged concrete channel walls**

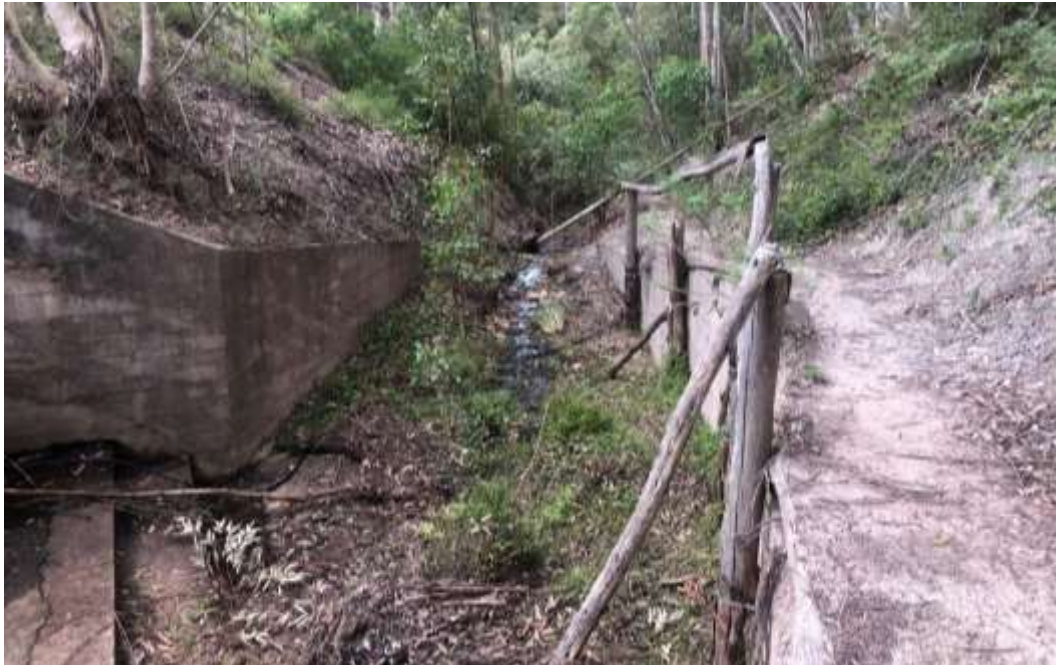
**Figure 4-11: Discharge channel**

**Condition of discharge channel:** In fair condition. The discharge channel is concrete lined, and the foundations downstream have been undercut by erosion. The channel is semi-blocked by debris and vegetation. The wooden handrails alongside the discharge channel should be refurbished.

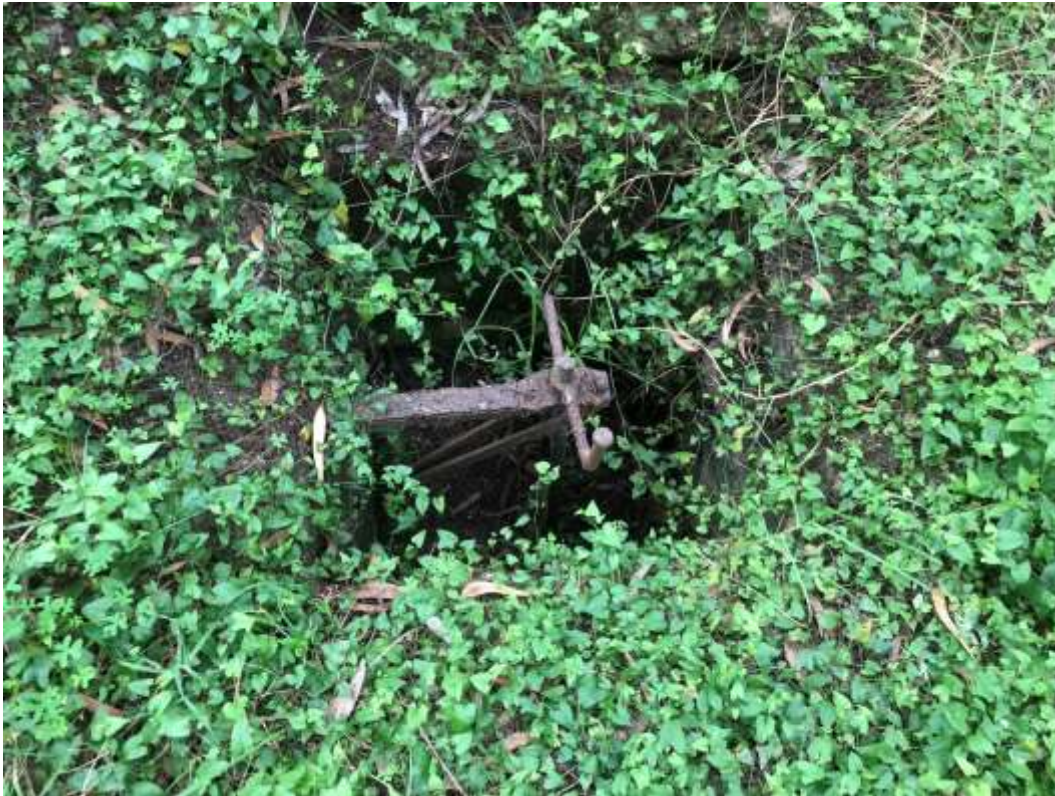
**Leakage / seepage:** Ponding and flowing water was observed in the vicinity of the downstream area where the outlet pipe is located. This could be the result of several causes including valve leakage and needs to be investigated.

**Figure 4-12: Spindle of suspected main outlet valve located at downstream toe of dam.**

**Access to outlet works:** The downstream area in the vicinity the outlet valve is overgrown and needs to be cleared.

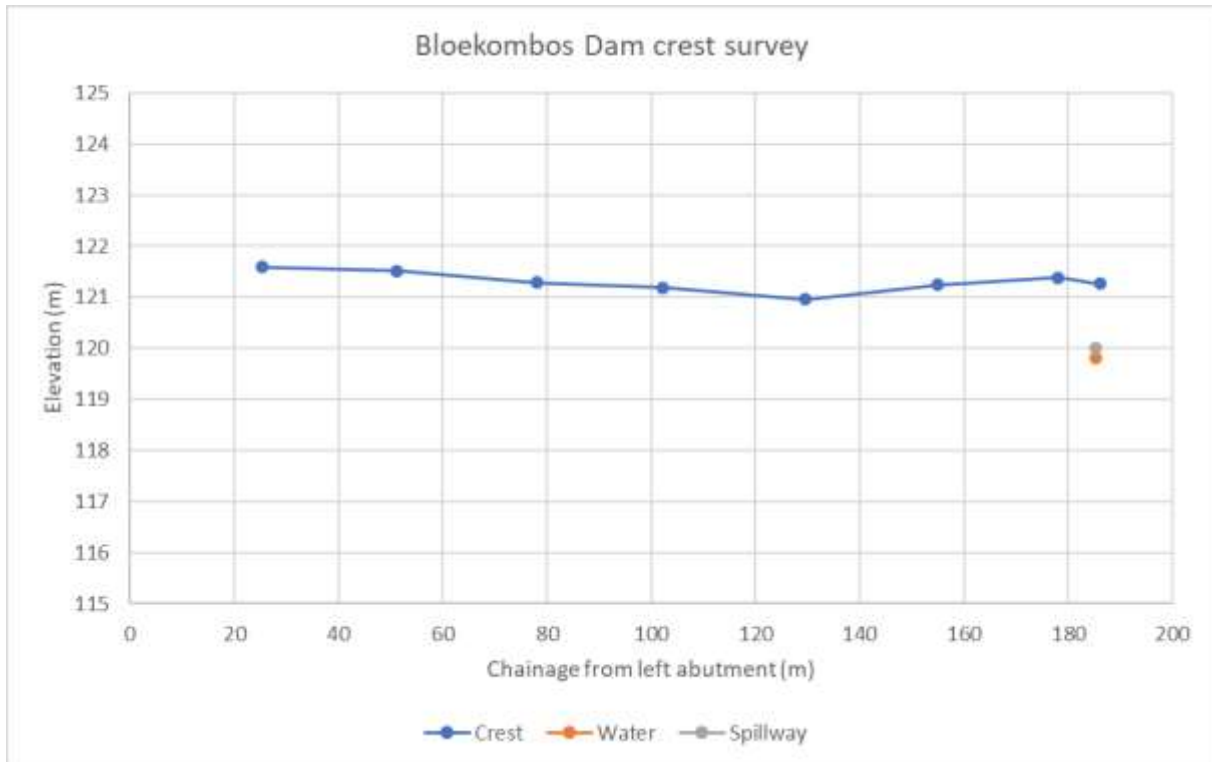
**Figure 4-13: Embankment Non-Overspill Crest levels**

It can be seen from Figure 4-13 that there appears to have been significant settlement towards the middle and right abutment. This is in the region noted as showing signs of undulations and this settlement could be attributed to erosion and slips. According to the crest survey, the dam has a minimum freeboard of 0.92 m with the level of the crest nearer the abutments having about 1.2 m to 1.5 m freeboard.
