TERRESTRIAL BIODIVERSITY IMPACT ASSESSMENT

PROPOSED WATER TREATMENT WORKS ON ERF RE/557 AND ERF 672
HEIDELBERG

Original Report Compiled September 2025
1st Revision Compiled February 2026

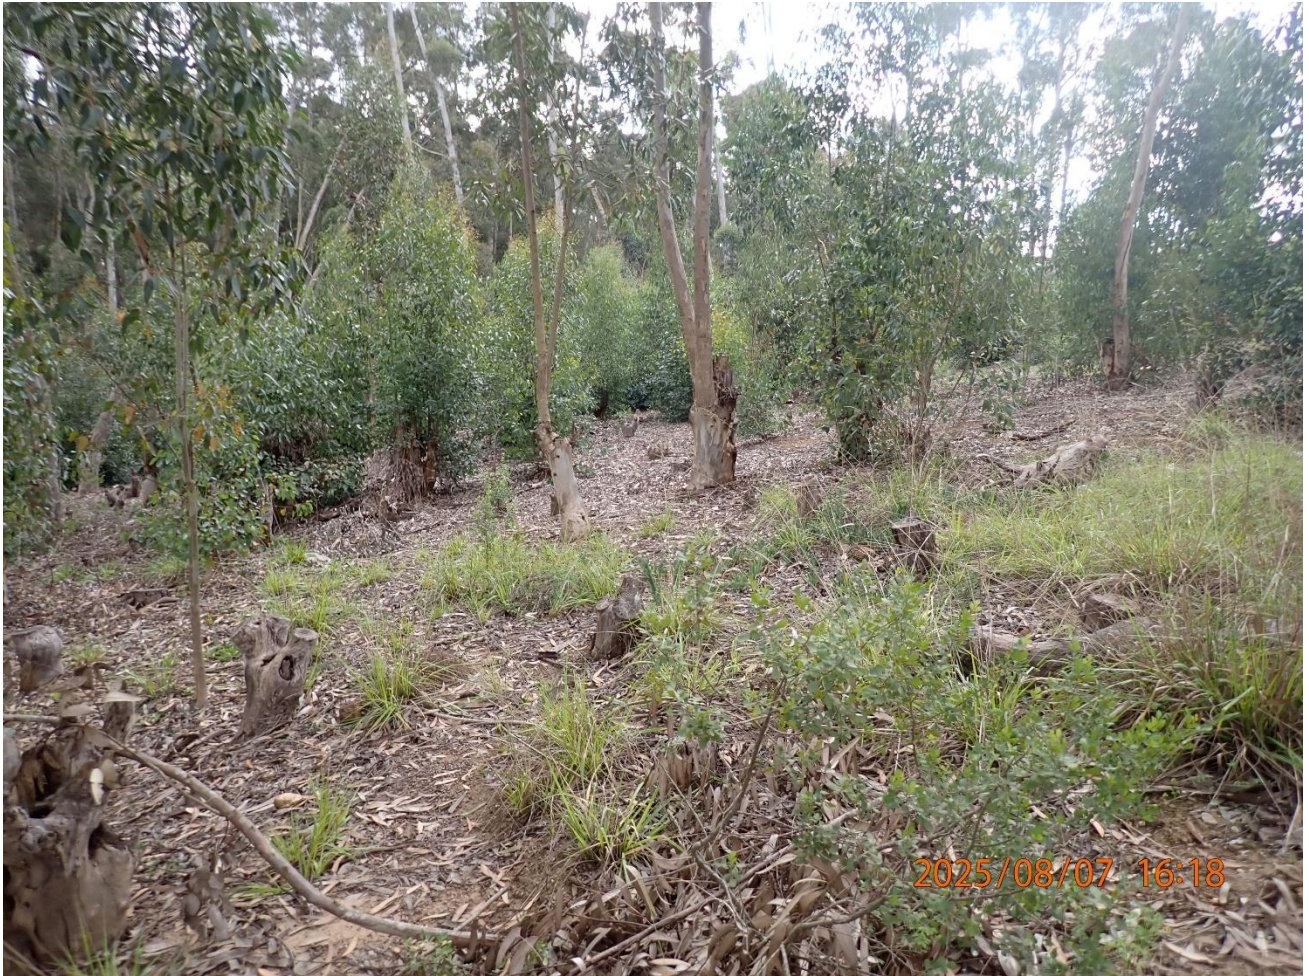
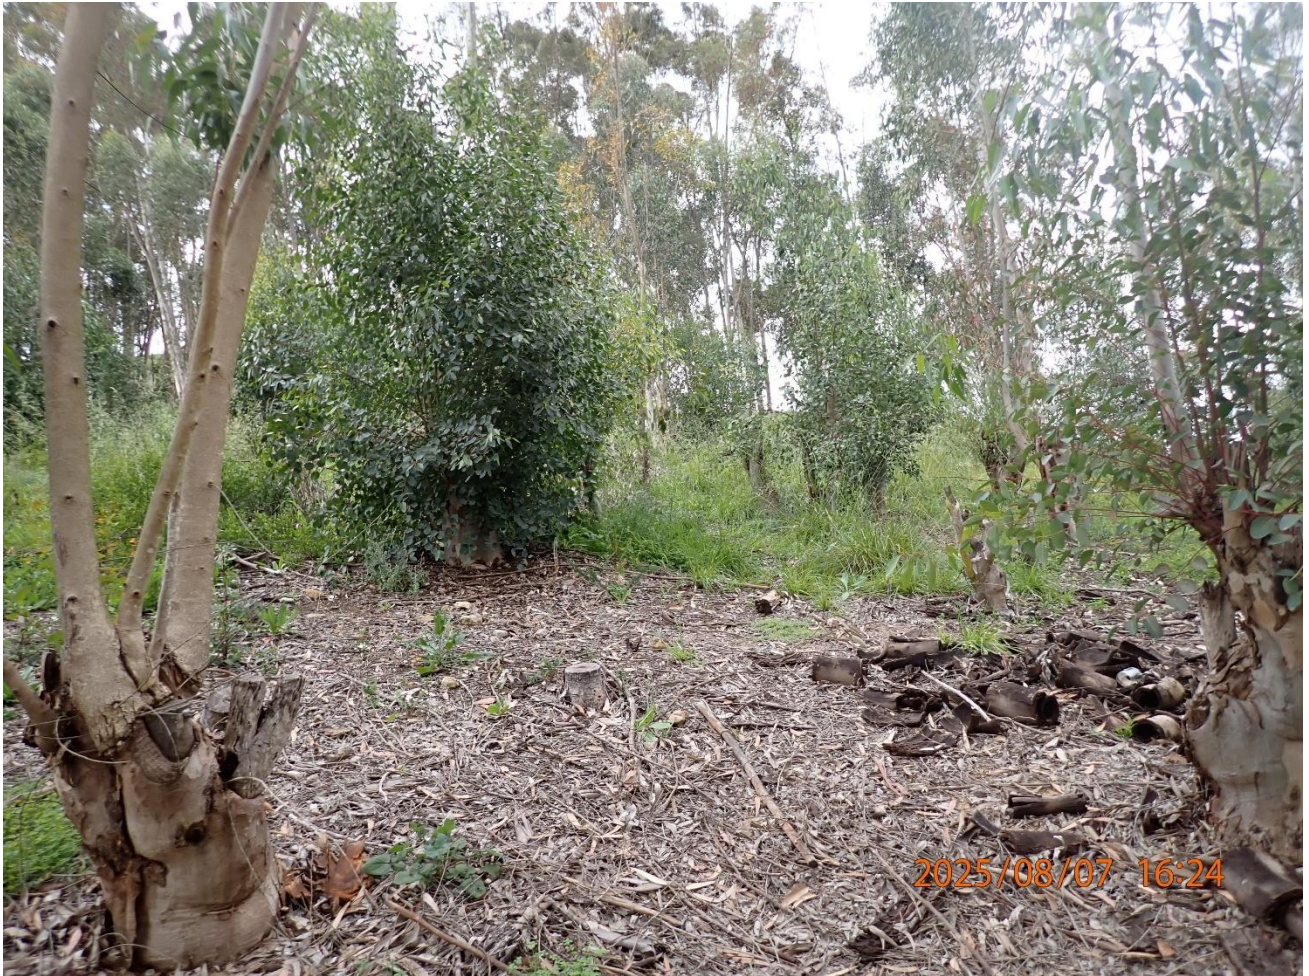
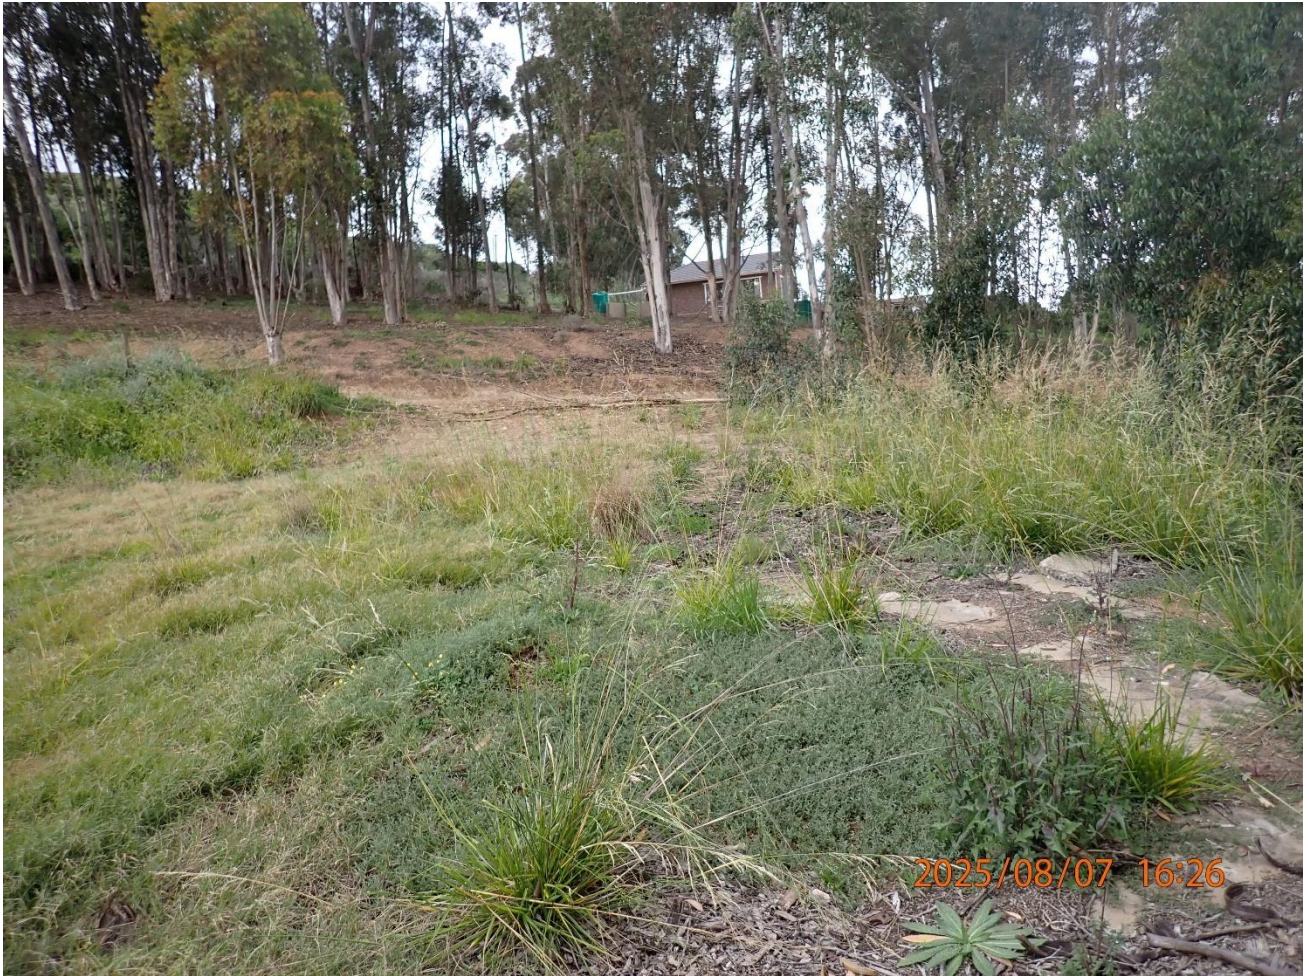
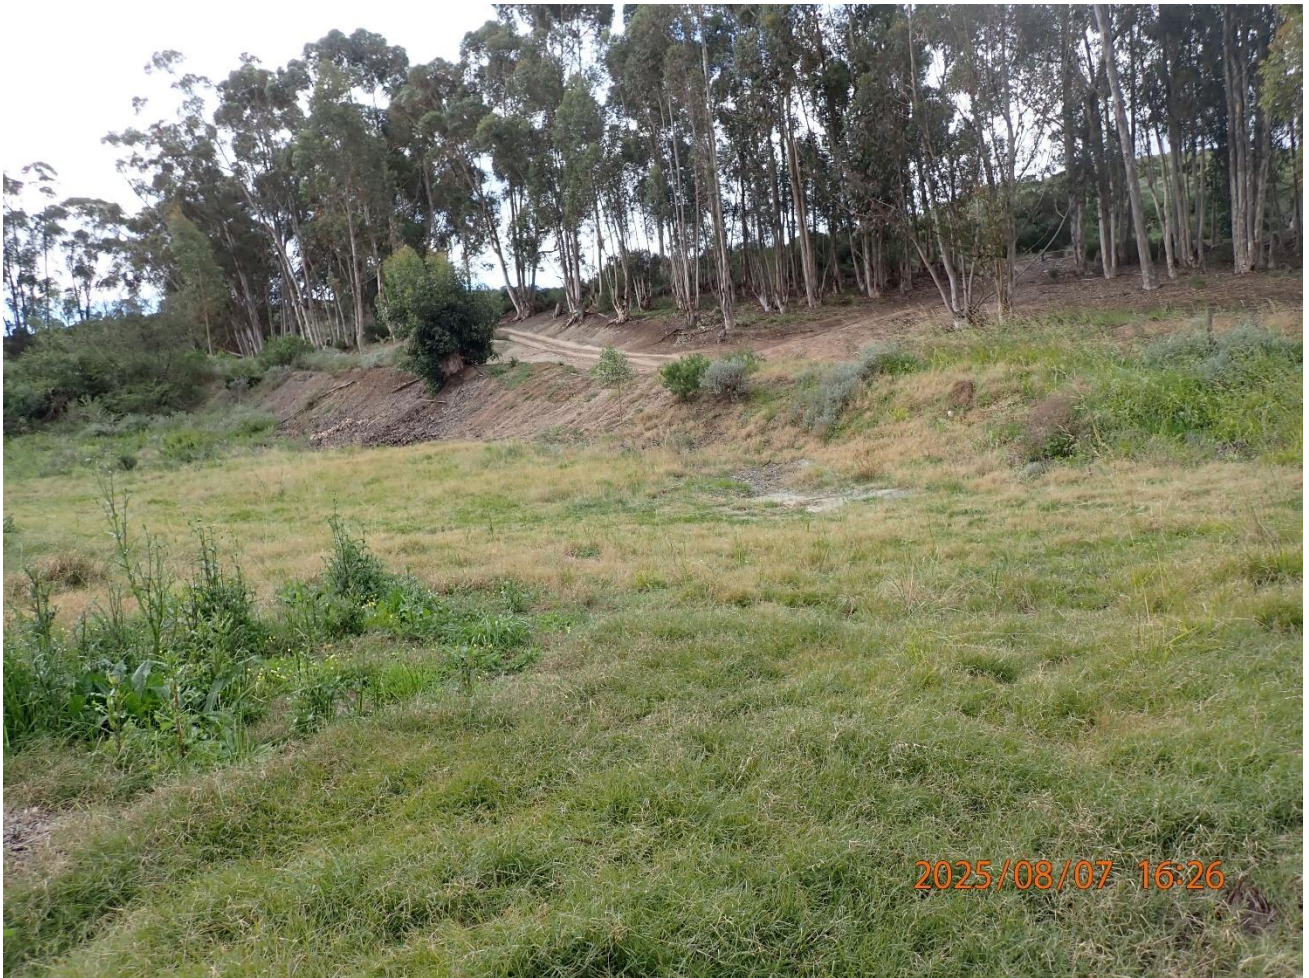
The vegetation impacted by the proposed development area is characterized and dominated by pioneer grasses and does not represent the vegetation structure of Eastern Ruens Shale Renosterveld. The vegetation was impacted by previous levelling of a portion of the site and roads (mapped as very low sensitivity) and the rest of the area by Eucalyptus tree plantation and consist mainly of pioneer plants. The following plant species were recorded on site during the survey on the development footprint. *Searsia glauca*, *Aloe forex*, *Asparagus burchellii*, *Ledebouria revoluta*, *Felicia amoena*, *Helichrysum patulum*, *Hypochaeris radicata*, *Aspalathus laricifolia* subsp. *Canescens*, *Oxalis pes-caprae*, *Digitaria eriantha* and *Haemanthus sp.*

Disturbed pioneer indigenous vegetation present of which a few species observed are listed above were recorded on the impact site. The vegetation would not be considered as representative of Eastern Ruens Shale Renosterveld. The earliest historical Google Earth imagery (2003) indicates the presence of a gum stand and fallow lands on the footprint indicating that the disturbance and invasion of aliens is not recent, as does the name of Bloekombos Dam from which water is abstracted. Areas subjected to longer periods of disturbance have reduced remnants indigenous species (including propagules) and lower restoration potential.

Photograph 1: Proposed development area.

Photograph 2: Proposed development area.

Photograph 3: Proposed development area.

Photograph 4: Proposed development area.

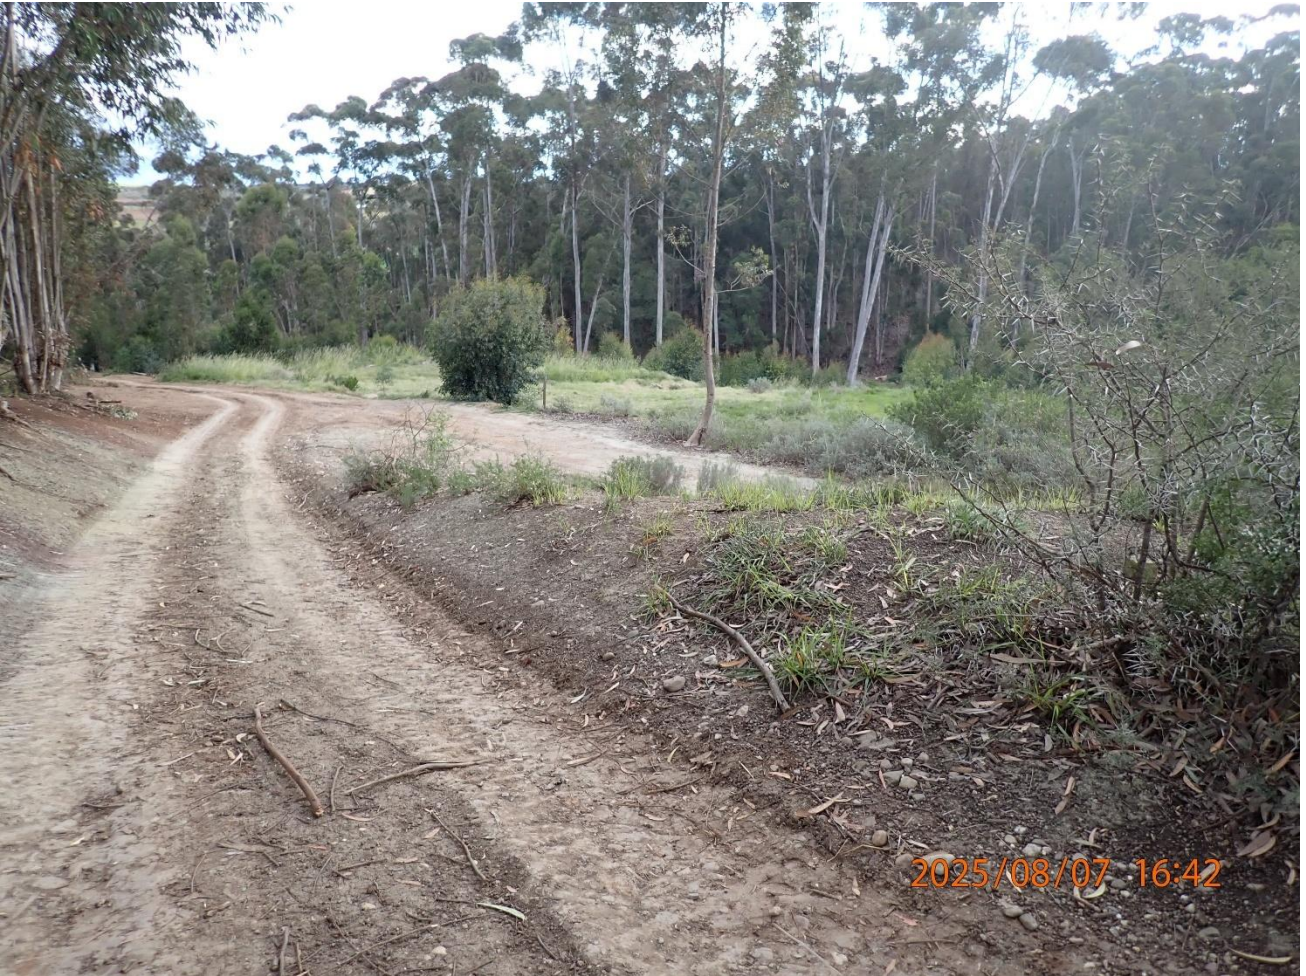
Photograph 5: Proposed development area and access road

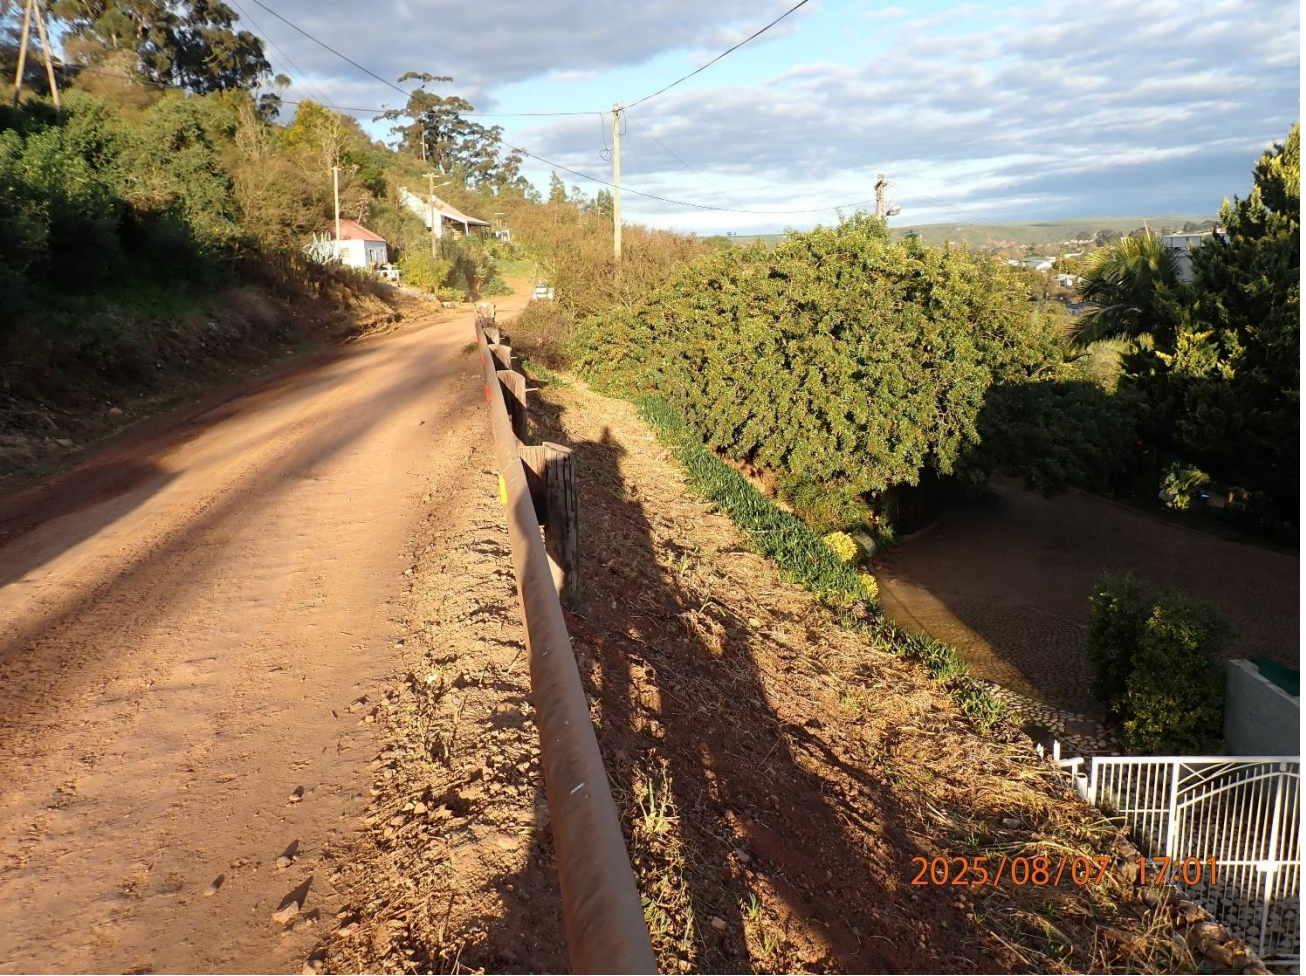
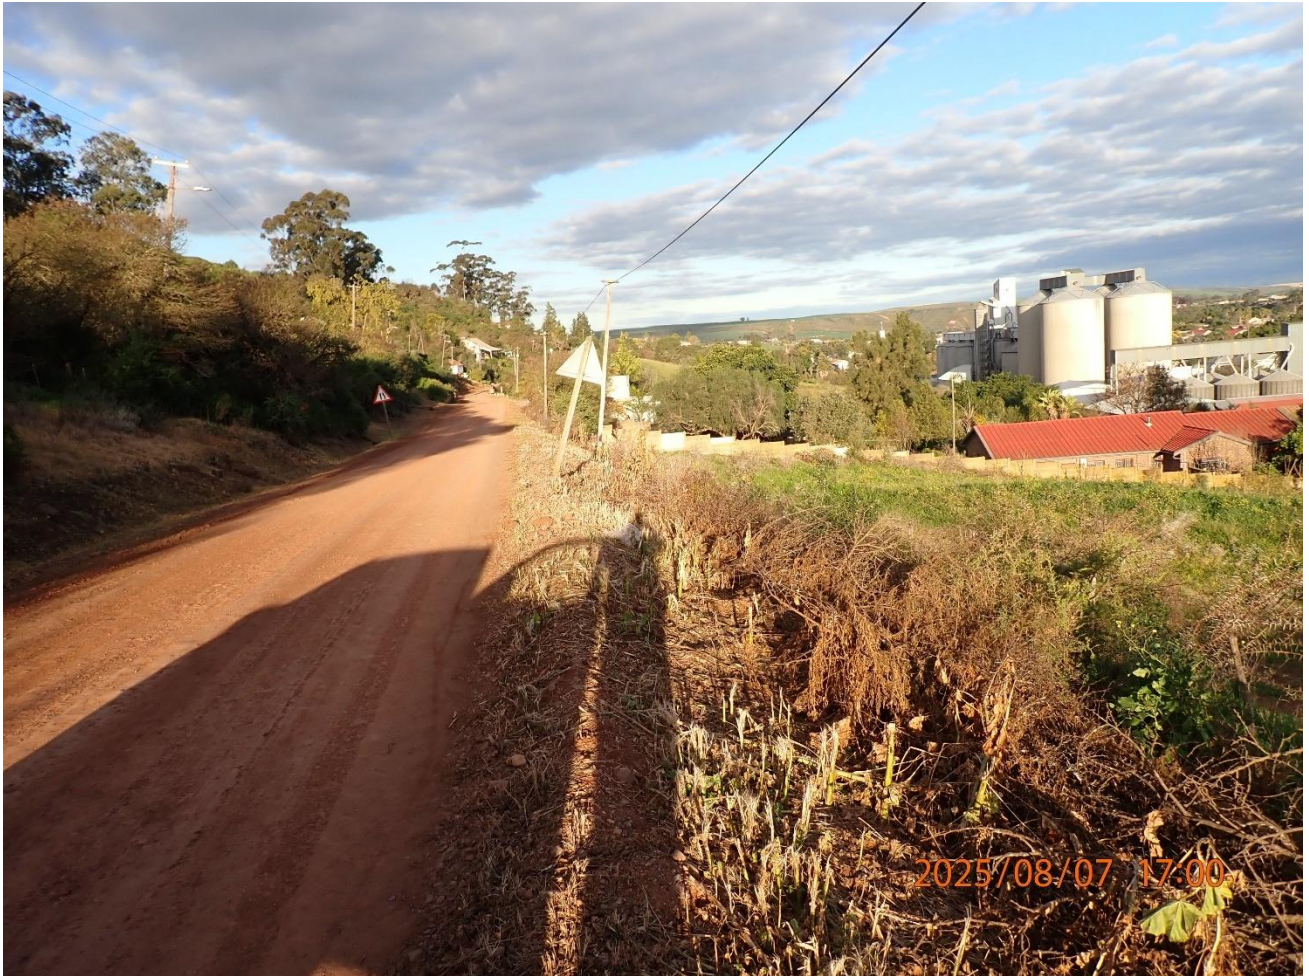
Photograph 6: Proposed pipeline connection route.

Photograph 7: Proposed pipeline connection route.

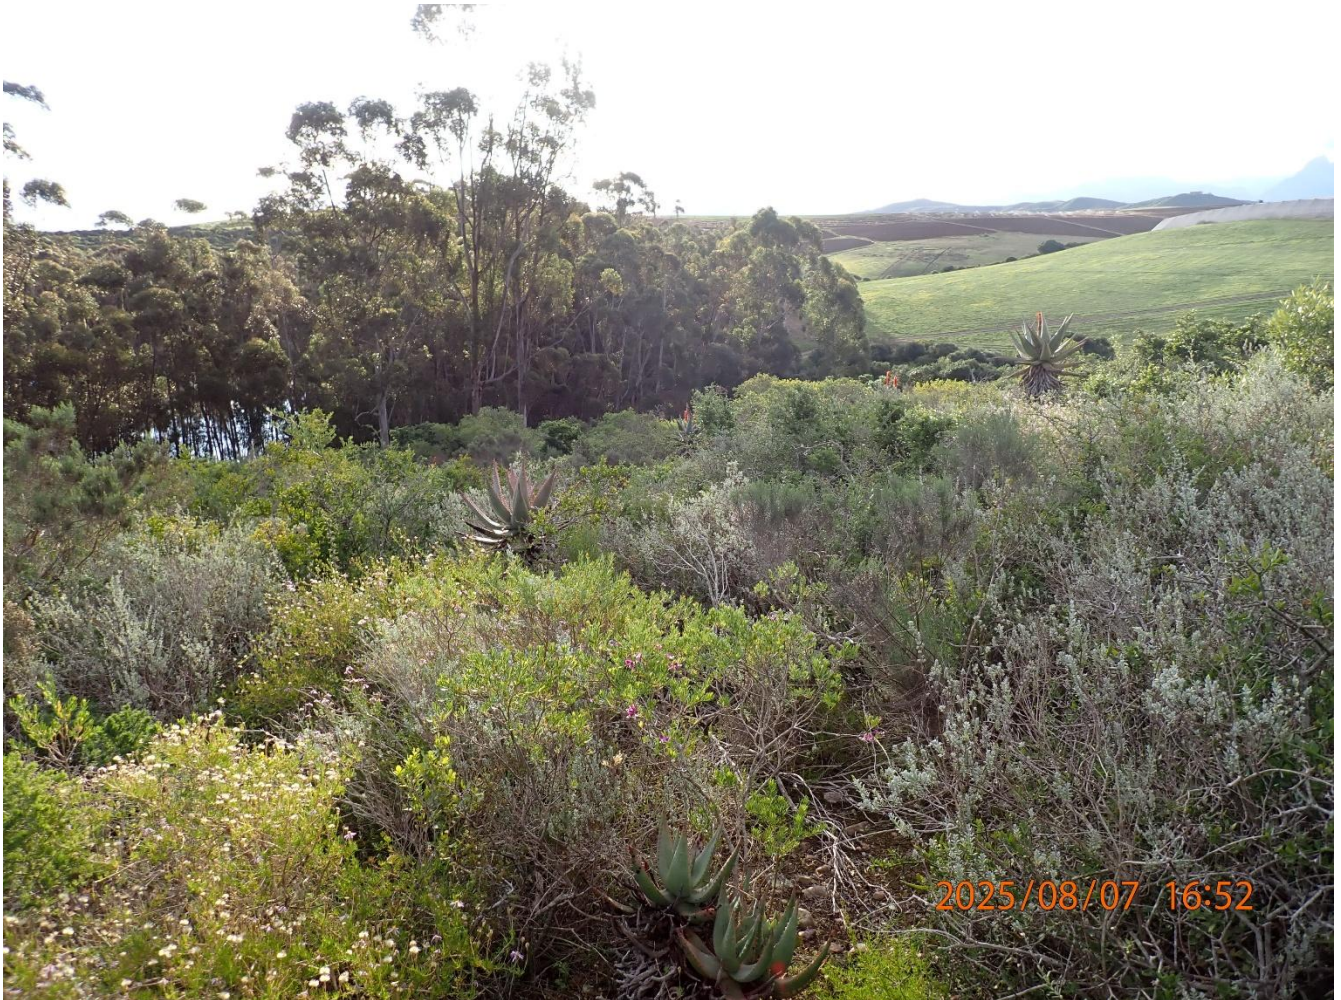
Photograph 8: View of a representative of vegetation structure of Eastern Ruens Shale Renosterveld that is located northeast of the development site. The representative and ecological vegetation structure between the development area (photographs above) and this area is clear and the degraded nature of the development area mapped as low sensitivity is clearly visible.

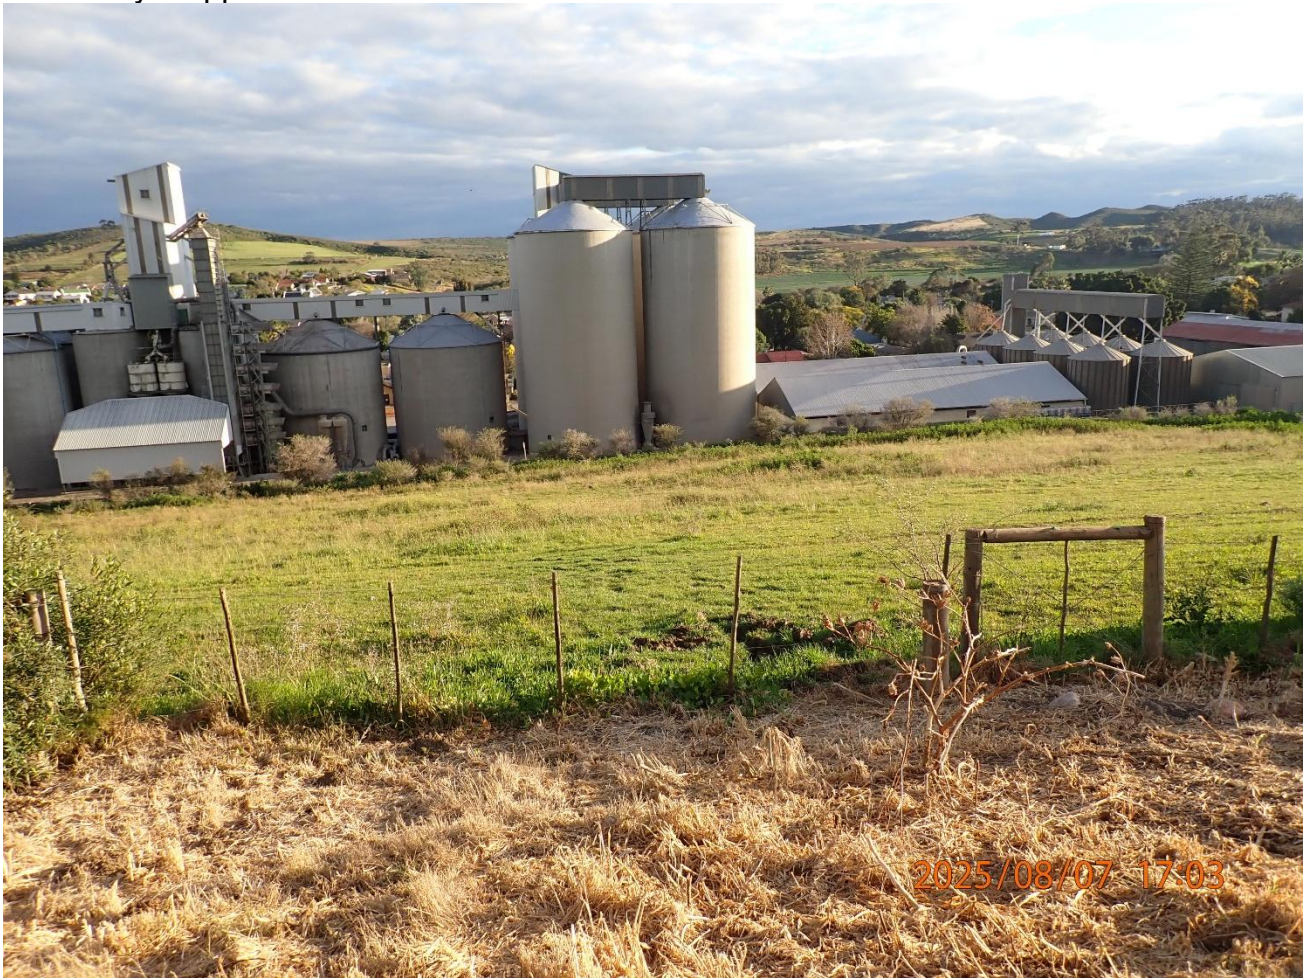
The site does not fall inside a FEPA. The NFEPA wetland mapped south of Muir Street was incorrectly mapped.

Photograph 9: View of cultivated and disturbed area mapped as NFEPA

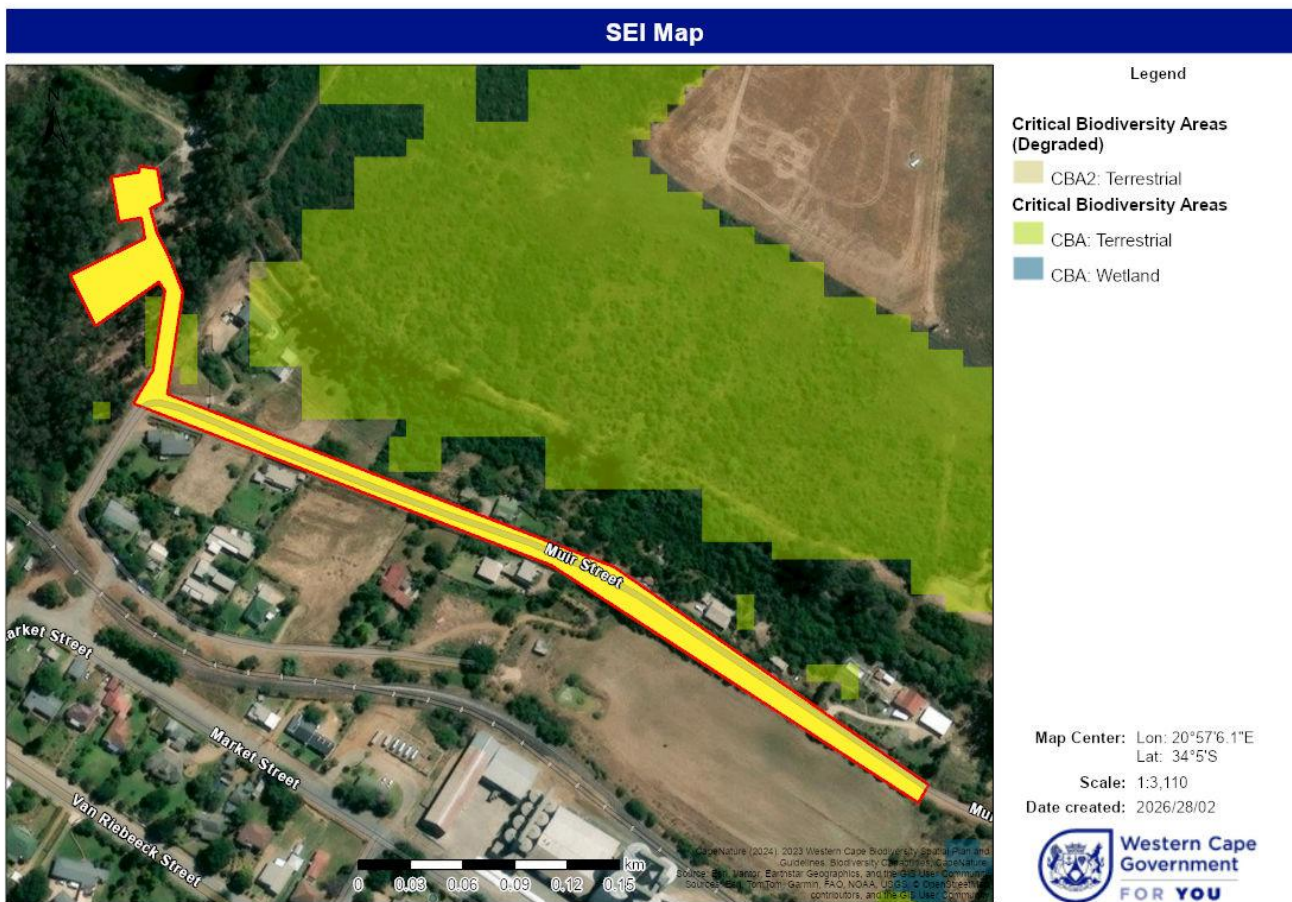
The proposed development area is therefore classified as a site with **very low Site Ecological Sensitivity** within the Projected Area of Influence.

Figure 4: Site Sensitivity Map. Yellow – very low sensitivity transformed, previously levelled area with Eucalyptus trees infestations.
