GEOTECHNICAL REPORT

**AN ENGINEERING
GEOLOGICAL INVESTIGATION TO ESTABLISH THE
GEOTECHNICAL CONDITIONS FOR PROJECT RM15876
PROPOSED NEW WATER TREATMENT WORKS FOR
HESSEQUA LOCAL MUNICIPALITY IN HEIDELBERG
IN THE WESTERN CAPE PROVINCE OF SOUTH AFRICA.**

REPORT REFERENCE : **GTL1086J**

DATE : **2024/06/25**

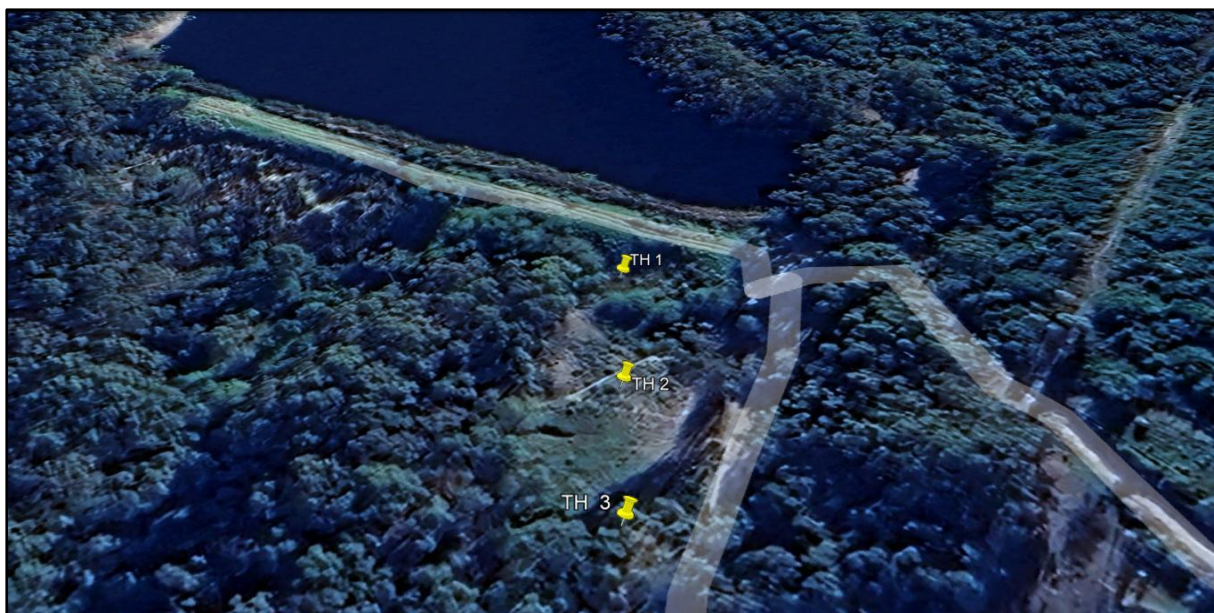
Trial Hole Positions for the site

The field investigation consisted of excavating three (3) trial holes, TH1 was excavated to 1400mm where refusal was encountered and TH2 & TH3 to 2000mm. These trial holes were profiled by a qualified Engineering Technician utilizing "The Revised Guide to Soil Profiling for Civil Engineering Purposes in Southern Africa" produced by Jennings, Brink, and Williams. From typical horizons, samples were extracted for Road Indicators, Foundation Indicators, California Bearing Tests and Collapse Potential tests.

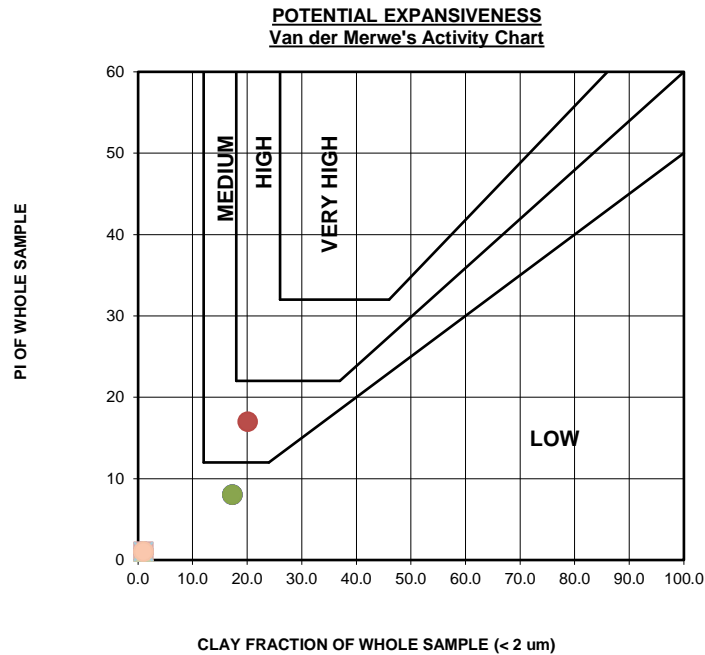
The Foundation Indicator tests results indicate that the materials tested have a low & medium potential expansiveness. The expansiveness classification is done in accordance with the Van der Merwe activity curves.

Potential Expansiveness Chart

| SAMPLE NUMBER | POSITION | DEPTH (mm) | DESCRIPTION | GM | LL (%) | PI (%) | LS (%) | PIWOLKE SAMPLE | 0.002mm (CLAY FRACTION) | POTENTIAL EXPANSSES |
|---|---|---|---|---|---|---|---|---|---|---|
| 9927 | TH 2 | 0 - 100 | dk, Br, silty sand with Organic Roots + clayey moddled silty clayey sand. | 0.66 | 23 | 9 | 3.6 | 17 | 45 | LOW |
| 9926 | TH 3 | 0 - 100 | dk, Br, silty sand, clayey Calcarious Gravel + clayey silty sand | 0.25 | 33 | 18 | 7.9 | 20 | 79 | MED |

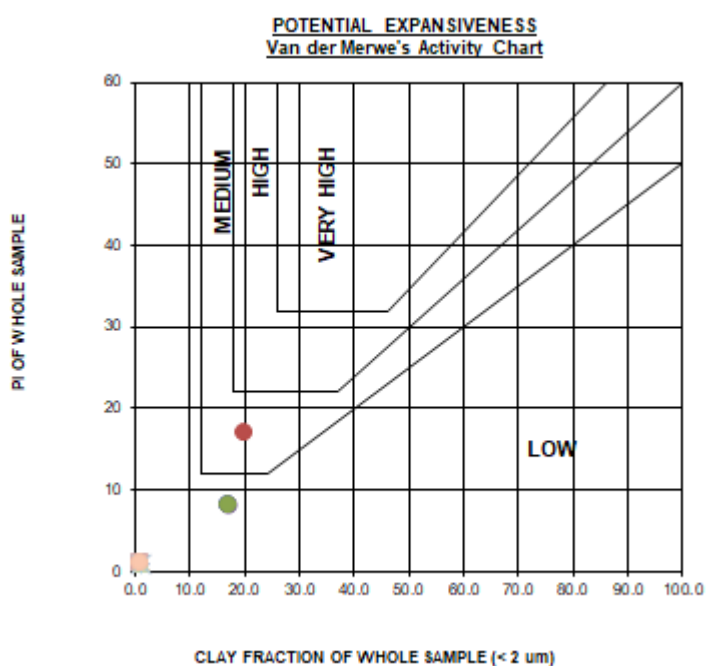
The Foundation Indicator tests results indicate that all the materials tested have a low / medium potential expansiveness. The expansiveness classification was done in accordance with the Van der Merwe activity curves.

The expansiveness classification was done in accordance with the Van der Merwe activity curves. The Plasticity Index of the whole sample 8% & 17% respectively and with the clay fraction (0.002mm sieve) 17.3mm and 20.1mm.

Potential Expansiveness Van der Merve's Activity Chart

The Foundation Indicator tests results indicate that all the materials tested have a low & medium potential expansiveness. The expansiveness classification was done in accordance with the Van der Merwe activity curves.

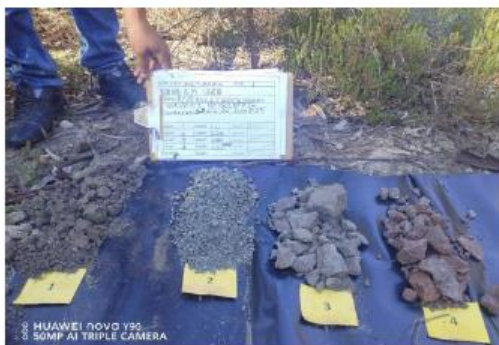
LAYER IDENTIFICATION PHOTOS

| Dark Brown, Slightly Moist, Firm, Sand. Intact, In-Situ (Residual) (HCL-) | | | | | | | |
| 140-520 (380) |

| Light Brown, Slightly Moist, Firm, Clay Intact, In-Situ (HCL+) | | | | | | | |
| 520-1086 (566) |

| Light Brown/Reddish, Slightly Moist, Firm, Clay. Intact, In-Situ (Residual) (HCL+) | | | | | | | |
| PHOTOS | | | | | | | | | |

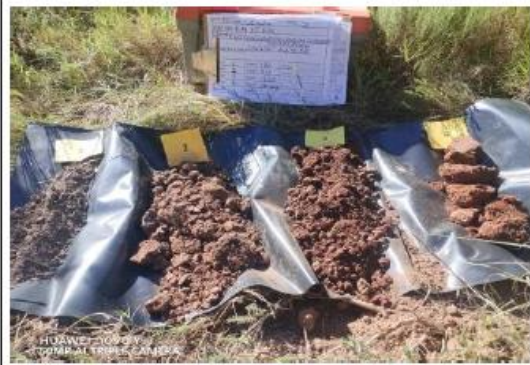
LAYER IDENTIFICATION PHOTOS

| Slightly Moist, Sand, Intact, In-Situ (Residual) (HCL-) | | | (F-Ind) Topsoil. | | | | | | |
| 180-910 (730) |

| Moist, Brown, Clayey / Silty / Calcareous sand Intact, In-Situ (HCL+) | | | MOD/CBR/IND | | | | | | |
| 910-1420 (510) |

| Reddish Brown, Moist, Clay Intact, In-Situ (HCL-) | | | MOD/CBR/IND | | | | | | |
| 1420-2000 (580) |

| Brown-Mottled-Reddish, Clay, Intact, In-Situ (Residual) (HCL-) | | | MOD/CBR/IND | | | | | | |
| PHOTOS | | | | | | | | | | | |

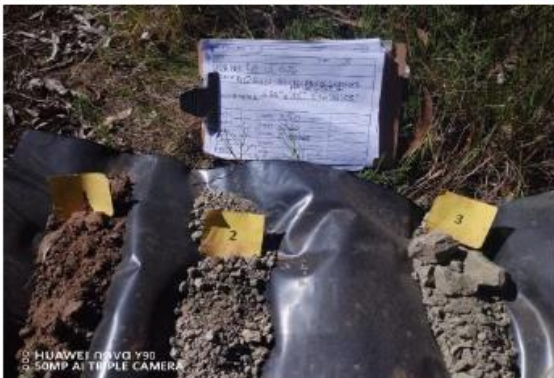
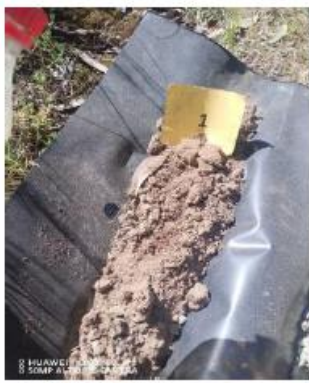
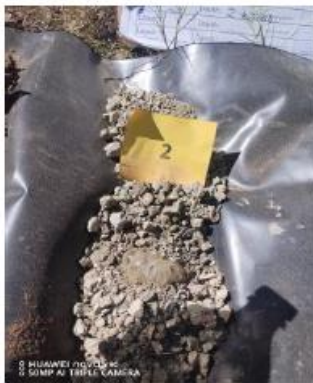
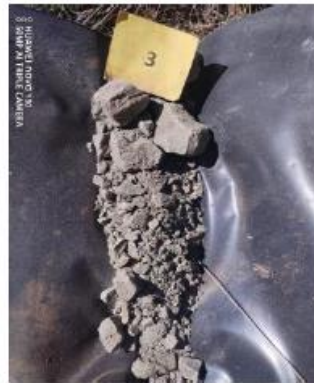
LAYER IDENTIFICATION PHOTOS

| | Moist, Topsoil, Intact, In-Situ (Residual) (HCL-) | | | | (F-Ind) Topsoil | | | | | | |
| 250-1260 (1010) |

| | Moist, Brown, Clayey / Silty / Calcareous sand Intact, In-Situ (HCL+) | | | | MOD/CBR/IND | | | | | | |
| 1260-2000 (740) |

| | Reddish Brown, Moist, Clay Intact, In-Situ (HCL+) | | | | MOD/CBR/IND | | | | | | |
| PHOTOS | | | | | | | | | | | | | |

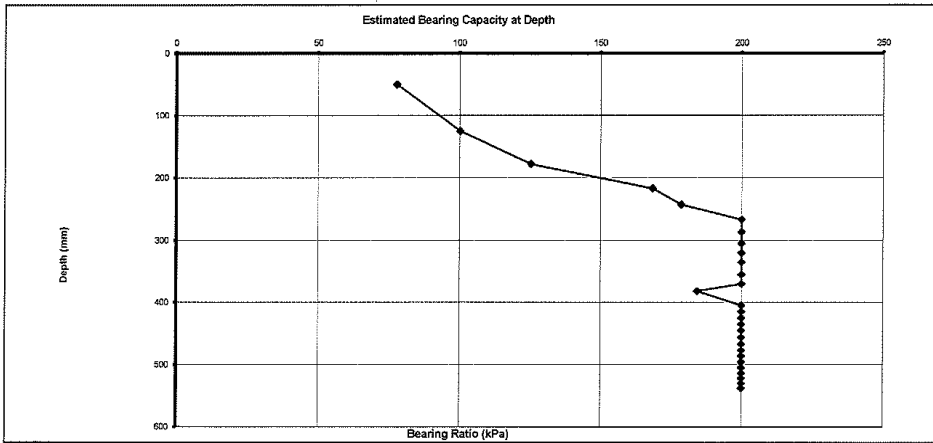
DCP GRAPHICAL REPRESENTATION

| <p>PROJECT: RFQ 84465</p> <p>CLIENT: Hessiqua Local Municipality</p> <p>TEST POSITION: Test Pit 1</p> <p>MATERIAL TYPE: Clayey Materials</p> <p>CONSTRUCTION TYPE: Structural</p> | <p>DATE TESTED: 2024.04.17</p> <p>OPERATOR: Mario Jackson</p> <p>STARTING DEPTH: 50mm</p> <p>INSTRUMENT USED: 2m DCP</p> <p>NOTE: Refuse @ 623mm</p> |

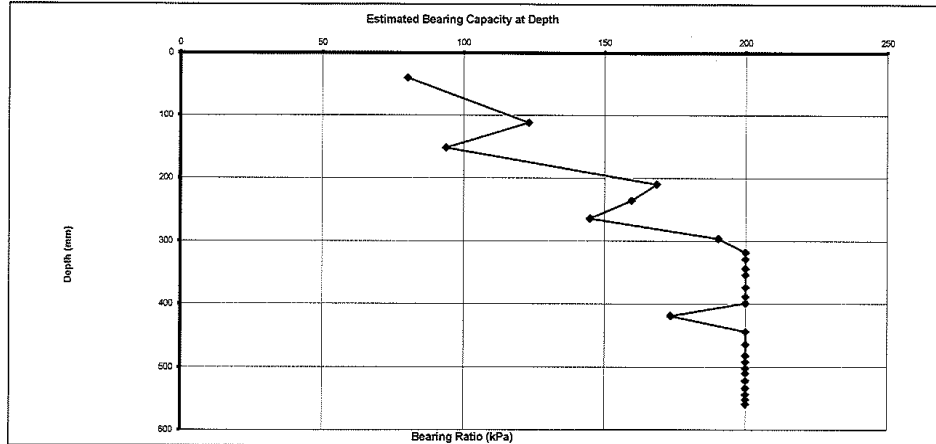
DCP GRAPHICAL REPRESENTATION

| <p>PROJECT: RFQ 84465</p> <p>CLIENT: Hessiqua Local Municipality</p> <p>TEST POSITION: Test Pit 2</p> <p>MATERIAL TYPE: Clayey Materials</p> <p>CONSTRUCTION TYPE: Structural</p> | <p>DATE TESTED: 2024.04.17</p> <p>OPERATOR: Mario Jackson</p> <p>STARTING DEPTH: 40mm</p> <p>INSTRUMENT USED: 2m DCP</p> <p>NOTE: Refuse @ 640mm</p> |

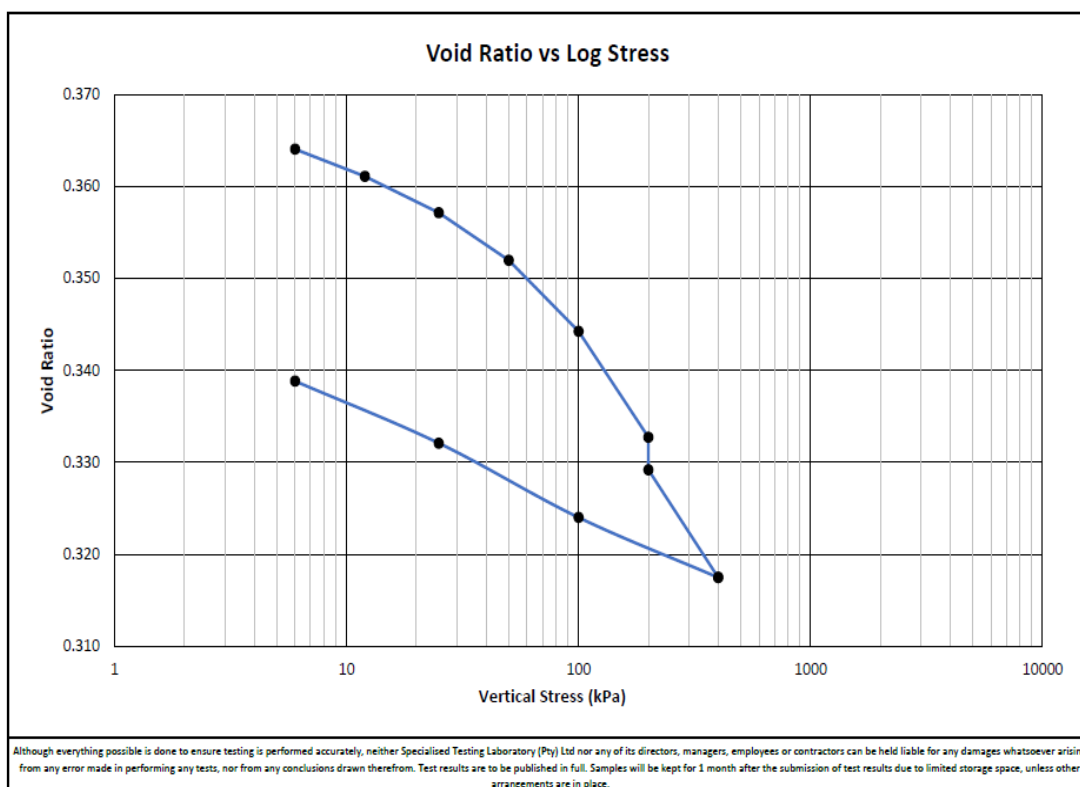
| Vertical Stress Applied: | kPa | 6 | 12 | 25 | 50 | 100 | 200 | 200 | 400 | 100 | 25 | 6 | | |
|---|---|---|---|---|---|---|---|---|---|---|---|---|--|--|
| Void Ratio | - | 0.364 | 0.361 | 0.357 | 0.352 | 0.344 | 0.333 | 0.329 | 0.317 | 0.324 | 0.332 | 0.339 | | |
| Mv (1/Mpa) | - | - | 0.362 | 0.223 | 0.152 | 0.114 | 0.086 | - | 0.044 | 0.017 | 0.081 | 0.267 | | |
