**Jarranhnup Piggery**  
**ENVIRONMENTAL AUDIT REPORT**

**Final Report: 6 DECEMBER 2025**

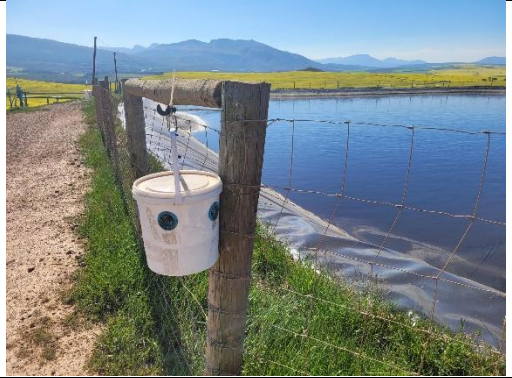
| WATER USE LICENCE. LICENCE NUMBER: 02/G40G/AGIAE/10115 : 02 DECEMBER 2020 | | | | |
|---|---|---|---|---|
| All wastewater dams must be lined with an appropriate lining to prevent any possible leachate and / or groundwater and soil contamination. | Appendix 1<br>Condition3 | C | 2 | All Wastewater dams are lined with an appropriate lining to prevent any possible leachate and / or groundwater and soil contamination. |

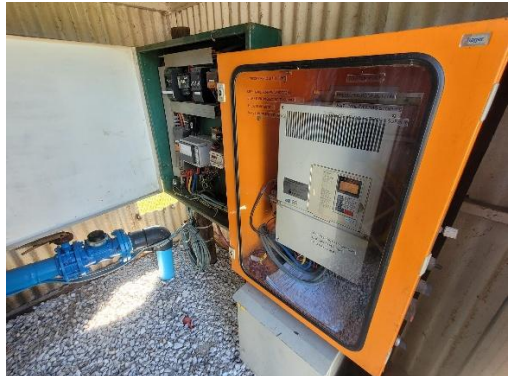
| The boreholes must be equipped with an observation tube (40 mm Class 10 PVC) to enable the water levels to be recorded easily and for easy installation of data loggers; a flow meter (pulse signal) and a sampling tap. An adjustable timer switch should also be installed to ensure the borehole does not pump for longer than 12 hours continuously. | Appendix 1<br>Condition 14 | C | 2 | <p>All was installed and monitoring was done.</p> <p>Photograph: Pump control box and metering</p> <p>Photograph: 40 mm Class 10 PVC</p> |

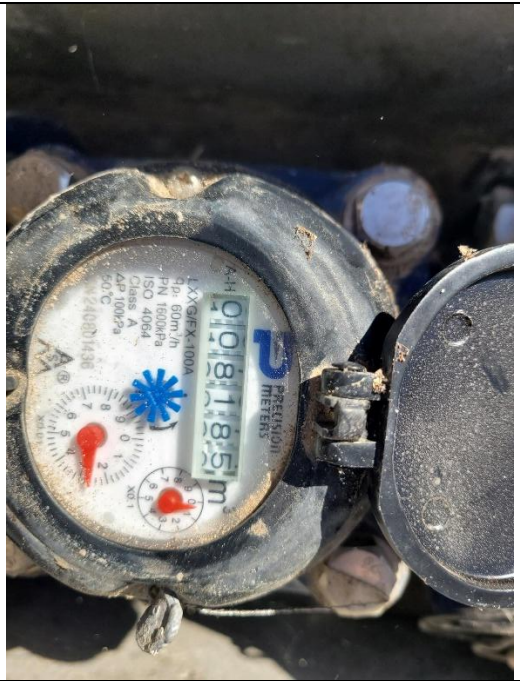
| <p>The appropriate borehole pump must be installed, i.e. not an over-sized pump that is choked with a gate valve. If the monitoring shows that more water can be abstracted, then the duration of pumping time will be increased (not the flow rate).</p> | <p>Appendix 1<br/>Condition 16</p> | <p>C</p> | <p>2</p> | <p>The water level is measured daily (towards the end of the 12-hour pumping cycle) and recorded in a database at the end of the month. Note this is a conservative safe yield (for use throughout the year). It is feasible that more groundwater can be abstracted and to accurately determine how much more water can be abstracted the borehole should be equipped with a continuous water level data logger.</p> |

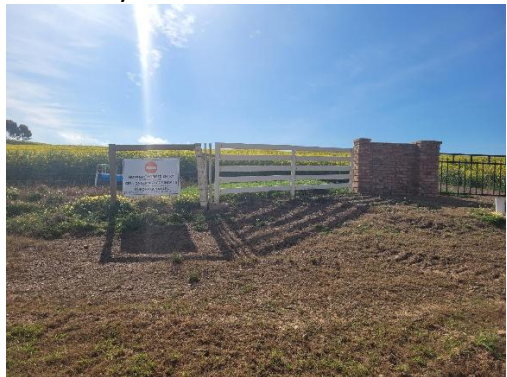
| Notices prohibiting unauthorised persons from entering the certain areas, as well as internationally acceptable signs indicating the risks involved in case of an unauthorised entry must be displayed along the boundary fence of these areas. | Appendix II: Condition 8 | C | 2 | <p>Notices prohibiting unauthorised persons from entering the certain areas, as well as internationally acceptable signs indicating the risks involved in case of an unauthorised entry was displayed along the boundary fence of these areas.</p> |

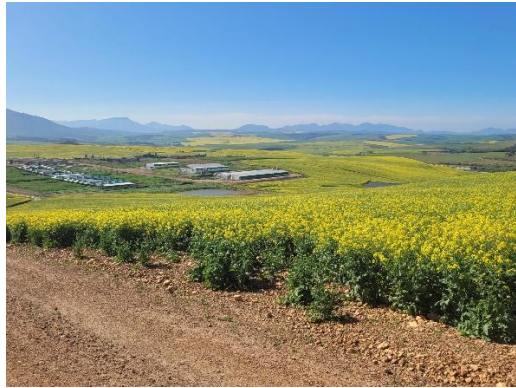
| Water Use as part of piggery operations: Wastewater Management and Disposal 19 924m3/a | Appendix IV: | C | 2 | <p>Here is the detailed summary of the Biodegradable effluent that is stored in the lined dam and what was spread onto the fields.</p> <p>One of the fields that effluent was disposed on.</p> |
