# Bloekombos Dam (H800/13): Second Dam Safety Evaluation Report

**Hessequa Local Municipality**

Ref no. 1000877-0000-REP-WW-0002

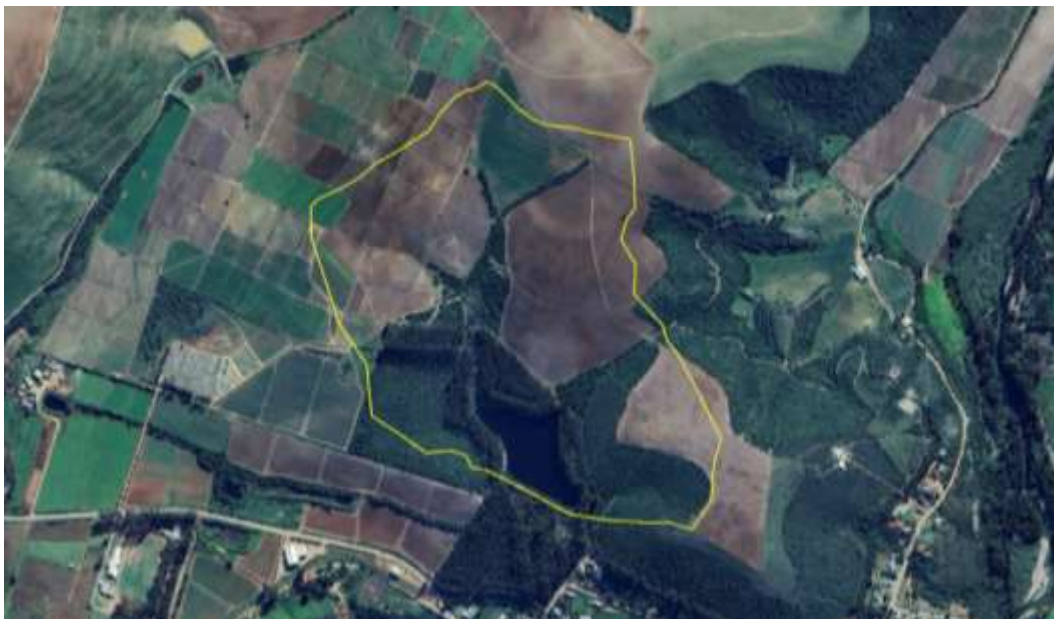
**Figure 5-1: Approximate catchment area of the Bloekombos Dam**

Bloekombos dam is effectively an off-channel dam located within a hilly catchment area. The dam has a tiny catchment area in the order of 0.6 km<sup>2</sup> directly upstream from it (refer to Figure 5-1). The dam is reportedly filled by canal / pipes from the Doorn River. There is some but very little runoff from its catchment.

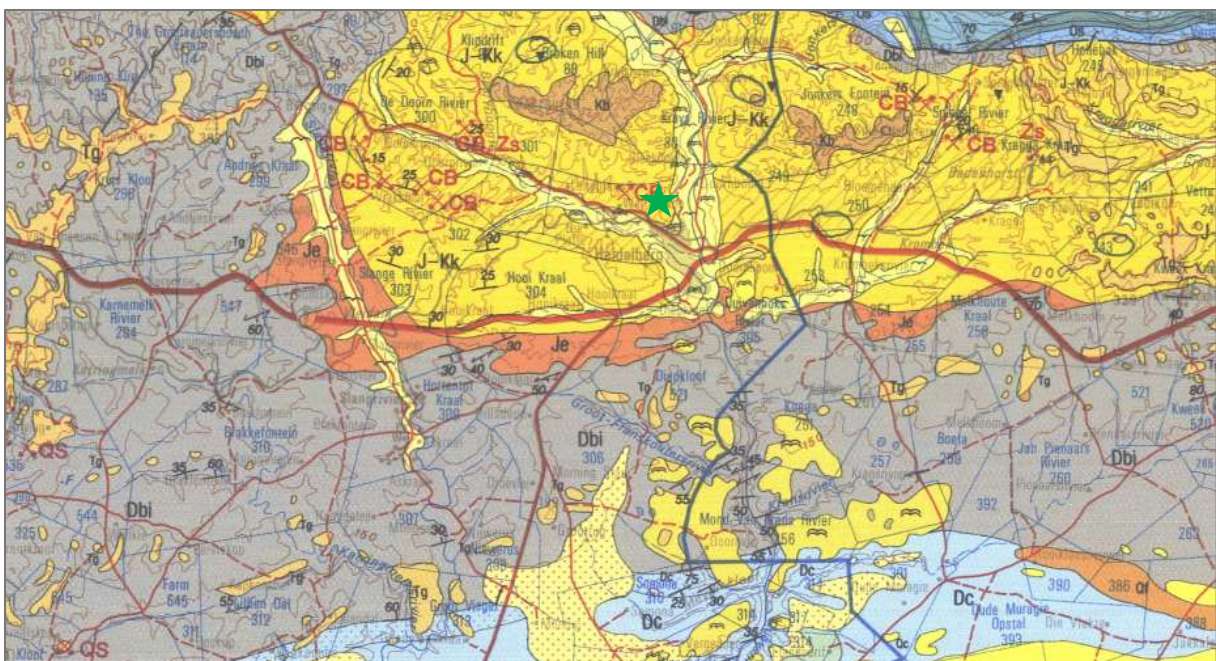
Figure 5-2: Regional geology at dam site (dam position indicated by green star)

The dam is founded on mudstone / sandstone of the Uitenhage Group of the Kirkwood formation. A snip of the regional geology map (3420 Riverside) is presented in Figure 5-2 below, which shows that the dam is on reddish and greenish mudstone, sandstone with subordinate conglomerate lenses; grey mudstone with tuff / bentonite layers.

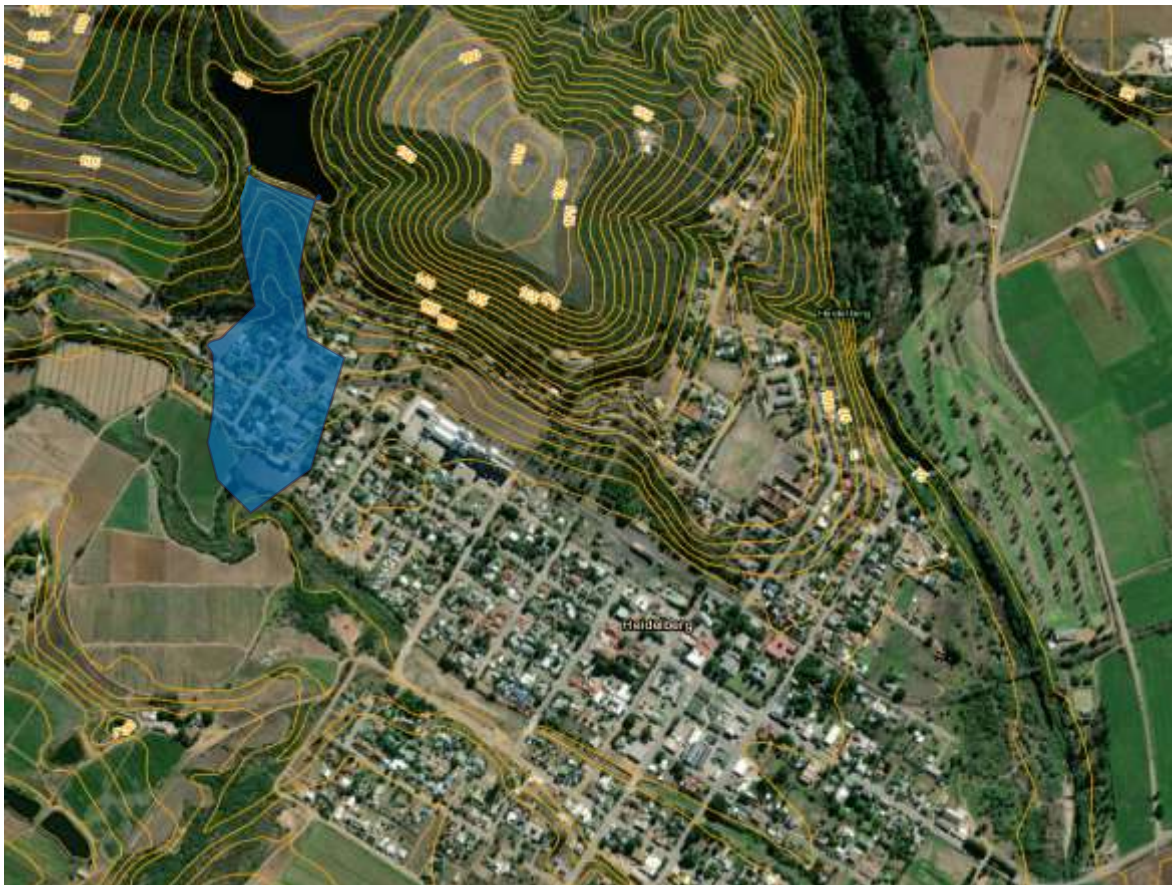
**Figure 7-1: estimated area downstream of dam at risk of low level inundation**

- ▶ Potential loss of lives is more than 1 and less than 10
- ▶ Potential economic loss is significant
- ▶ Potential adverse impact on resource quality is low to significant

The dam is of “medium” size and this report estimates a “significant” hazard potential, it’s classification as a Category II dam is therefore still deemed valid.
